# Manhole Inspection Summary

Manhole # S25CC\_051MH

Insp Date: **10/17/07 10:35 AM**

**Location** Address: **1005 ARLINGTON AVE**

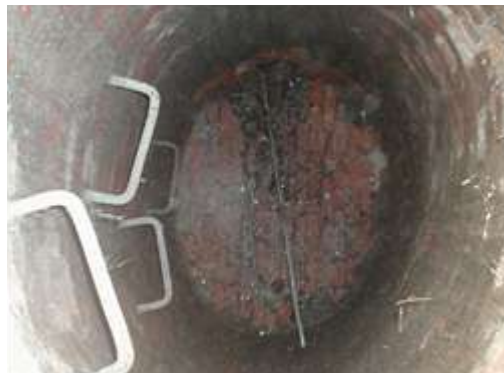
Top View

Channel debris.

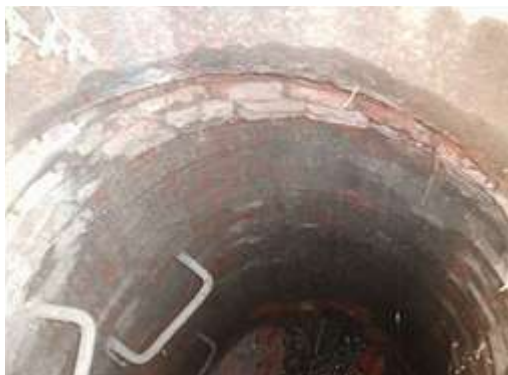
Defect

Frame leaks. Adjustment deterioration and infiltration. Corbel and Barrel infiltration - other side.

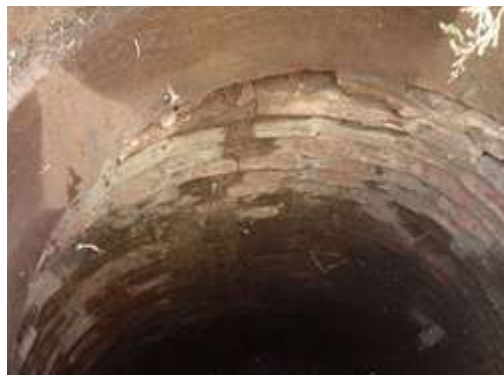
Defect

Frame leaks. Adjustment deterioration and infiltration. Corbel and Barrel infiltration.

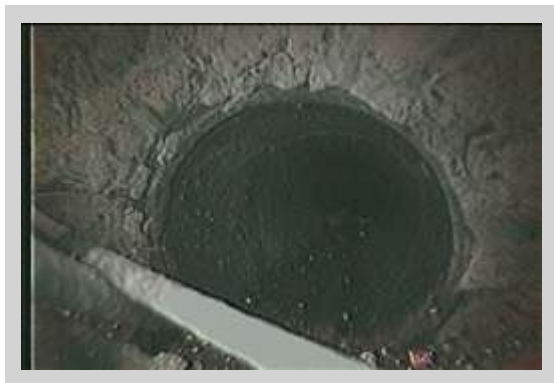
Pipe Out @ 12 O'Clock

Infiltration: **Evidence**

Pipe Seal Cond: **Cracked**
